CAPITAL RESERVE STUDY

CATEGORY 2: UPDATE WITH ON-SITE REVIEW

EDISON GLEN TERRACE CONDOMINIUM ASSOCIATION EDISON GLEN TERRACE, EDISON, NEW JERSEY 08837

Fiscal Year: 2023
Fiscal Year Date Span: January 1, 2023 - December 31, 2023
Care of: Towne & Country Property Management
On-Site
Job Number 1440.0004
Prepared: December 2022
Finalized: December 2022

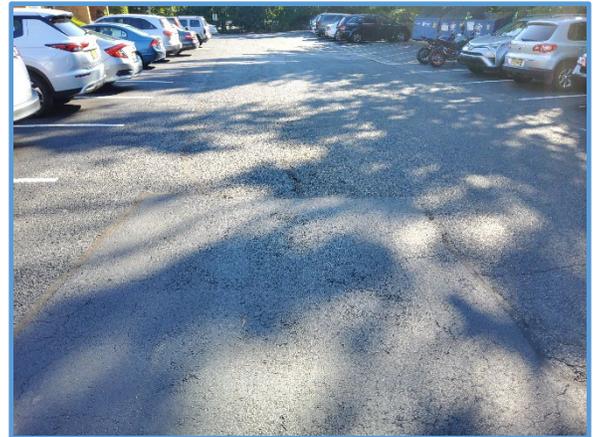
[Asphalt Parking Area](#)

The existing surfaces of the roadway were observed to be in below average condition showing signs of cracking and areas of failure. Prior to the installation of a new wearing course, milling, crack repair, and reconstruction of base course failure are expected to occur. The costs to perform these additional operations are included in the unit cost provided within the schedule.

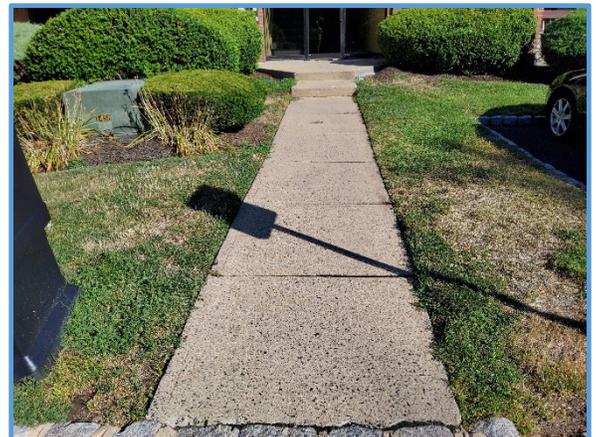
[Concrete Sidewalk](#)

The sidewalks at the community are constructed of Portland Cement concrete, which has a typical useful life of thirty (30) years. The sidewalks were observed to be in average to below average condition with deficiencies including cracks, spalling, and areas of erosion. Any areas of sidewalk posing possible trip or *safety* hazards should be replaced immediately to eliminate the hazard.

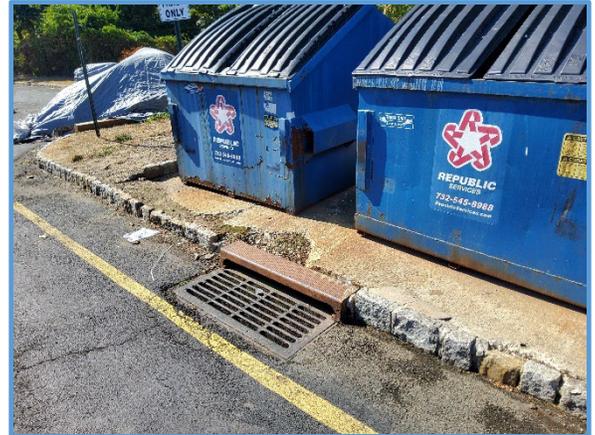
Refuse Area

The refuse enclosures and areas are constructed of a six (6”) inch thick concrete dumpster pad and six (6’) foot tall wood fencing. These components were observed to be in below average condition with the concrete exhibiting displacement and deterioration, while the wood fencing exhibited wood deterioration and incidental damage.

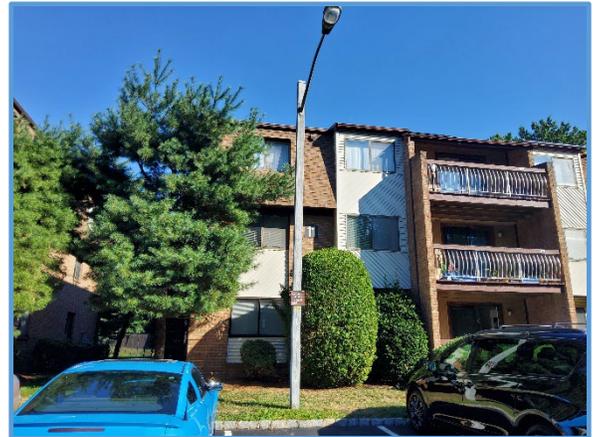
Pole-Mounted Light Fixture

The exterior areas of the community are illuminated by pole-mounted light fixtures, which possess a typical useful life of twenty-five (25) years. These components were observed to be in average condition.

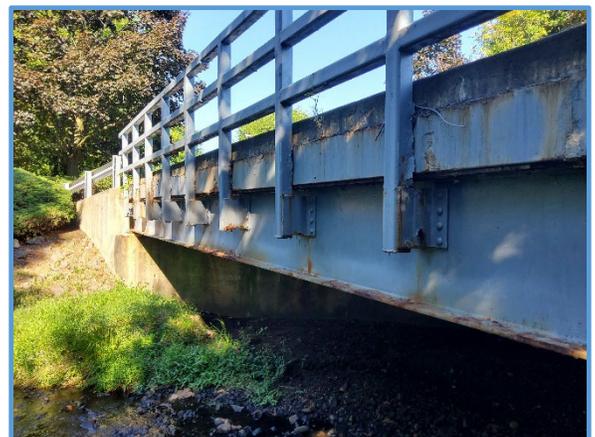
Bridge

The bridge located within the community was observed to be in below average condition. The bridge presented signs of corrosion and deterioration of the steel and concrete components. An allowance for the renovation of the bridge has been included within the study to allow the Association to fund towards the renovation project.

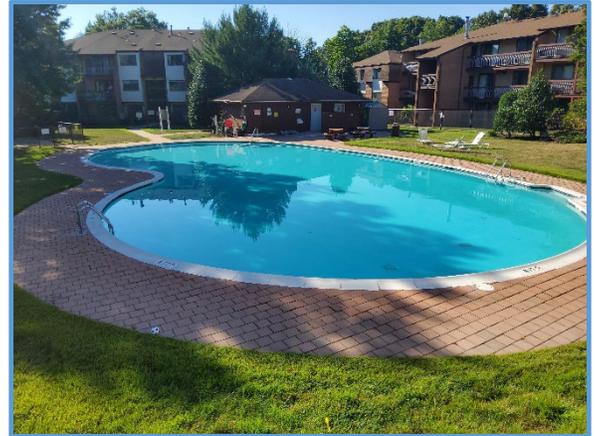
Outdoor Swimming Pool

The outdoor swimming pool and spa will require resurfacing of the interior marcite plaster, typically occurring every seven (7) years, and replacement of the coping and waterline tile, which typically occurs every fourteen (14) years. The pool was observed to be in average condition, while the spa was covered and not visible during the inspection by FWH.

The pre-cast concrete paver pool deck possesses a typical useful life of thirty (30) years and was observed to be in average condition.

A six (6') foot tall chainlink fence encloses the pool area and has a typical useful life of twenty-five (25) years. The fencing was observed to be in below average condition showing signs of incidental damage, finish loss, and leaning.

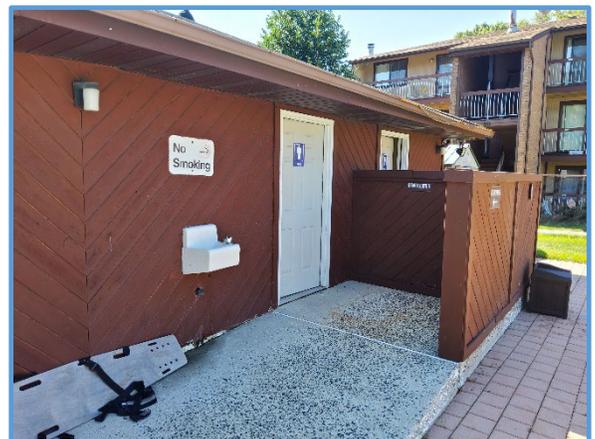
Pool Building

The pool building is weatherproofed with 3-tab roofing shingles, which possess a typical useful life of twenty (20) years. The roofing shingles were observed to be in below average condition and will be replaced with architectural shingles, which have a longer typical useful life, during the next replacement effort.

The aluminum gutters and aluminum leaders have a typical useful life of twenty (20) years and were observed to be in average condition for their age.

The wood siding cladding the exterior of the building was observed to be in average condition and has a typical useful life of forty-five (45) years.

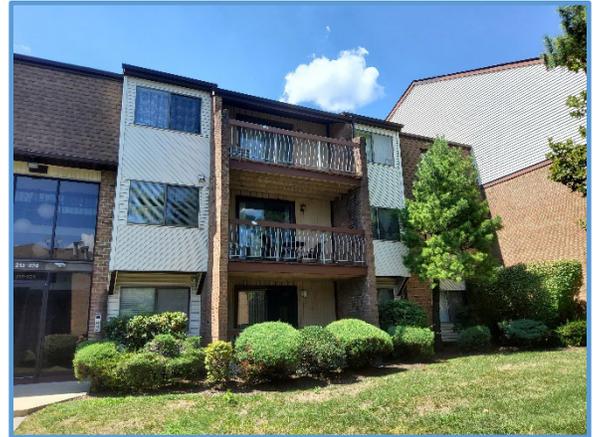
Residential Building Exterior

The residential buildings are weatherproofed with architectural roofing shingles, which possess a typical useful life of thirty (30) years. The roofing shingles were observed to be in average condition.

The aluminum gutters and aluminum leaders have a typical useful life of twenty (20) years and were observed to be in average condition for their age.

The exterior elevations of the residential buildings are clad with wood siding, vinyl siding, and brick veneer. The wood siding and vinyl siding have a typical useful life of forty-five (45) years, while the brick veneer will require repointing of the mortar joints typically occurring every thirty (30) years. The cladding was observed to be in average condition.

The wood decks and aluminum deck railings were observed to be in below average condition experiencing warping and separation of the rim joists, severe deterioration of the wood, post checking, and post twisting. FWH recommends that the decks are evaluated and repairs are made immediately to these components.
